**AREA B - EAST/WEST STREETS
EXISTING LIGHT LEVELS VERSUS
PROPOSED CRITERIA**

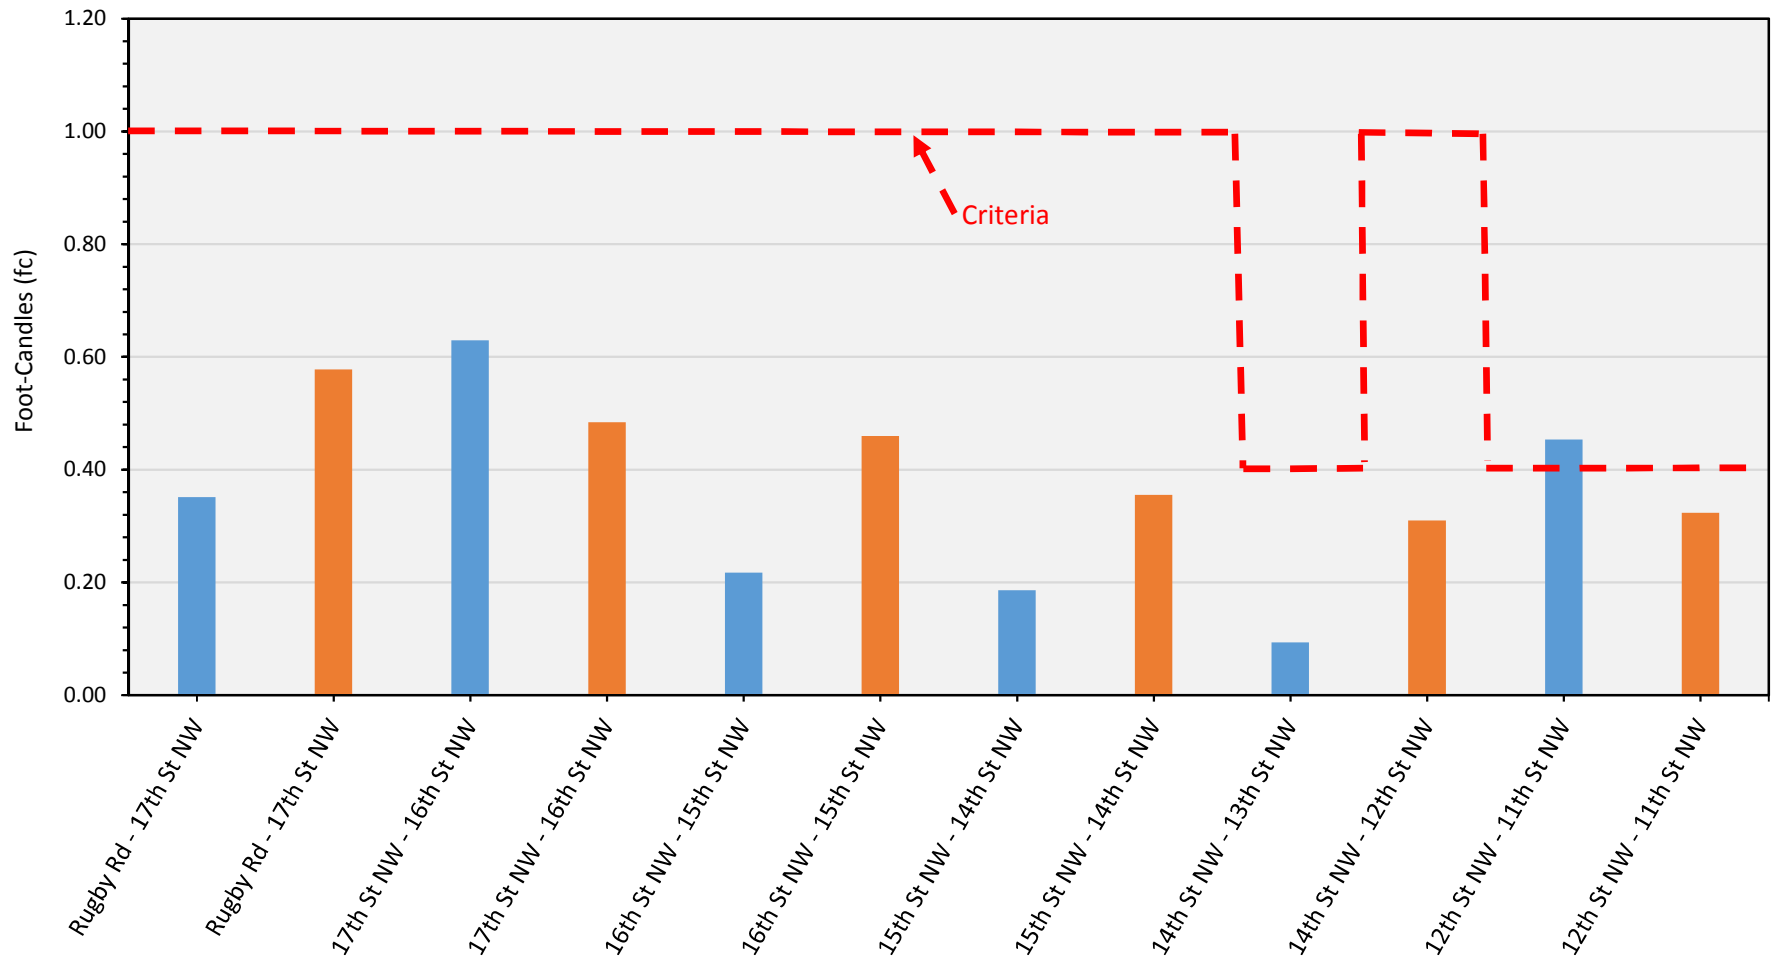
Gordon Ave - Average Illuminance from Existing Lighting

Gordon Ave

Sidewalk Width: 5ft

Adjacent Land Use: Residential

Functional Classification: Local

Pedestrian Activity: High, Low

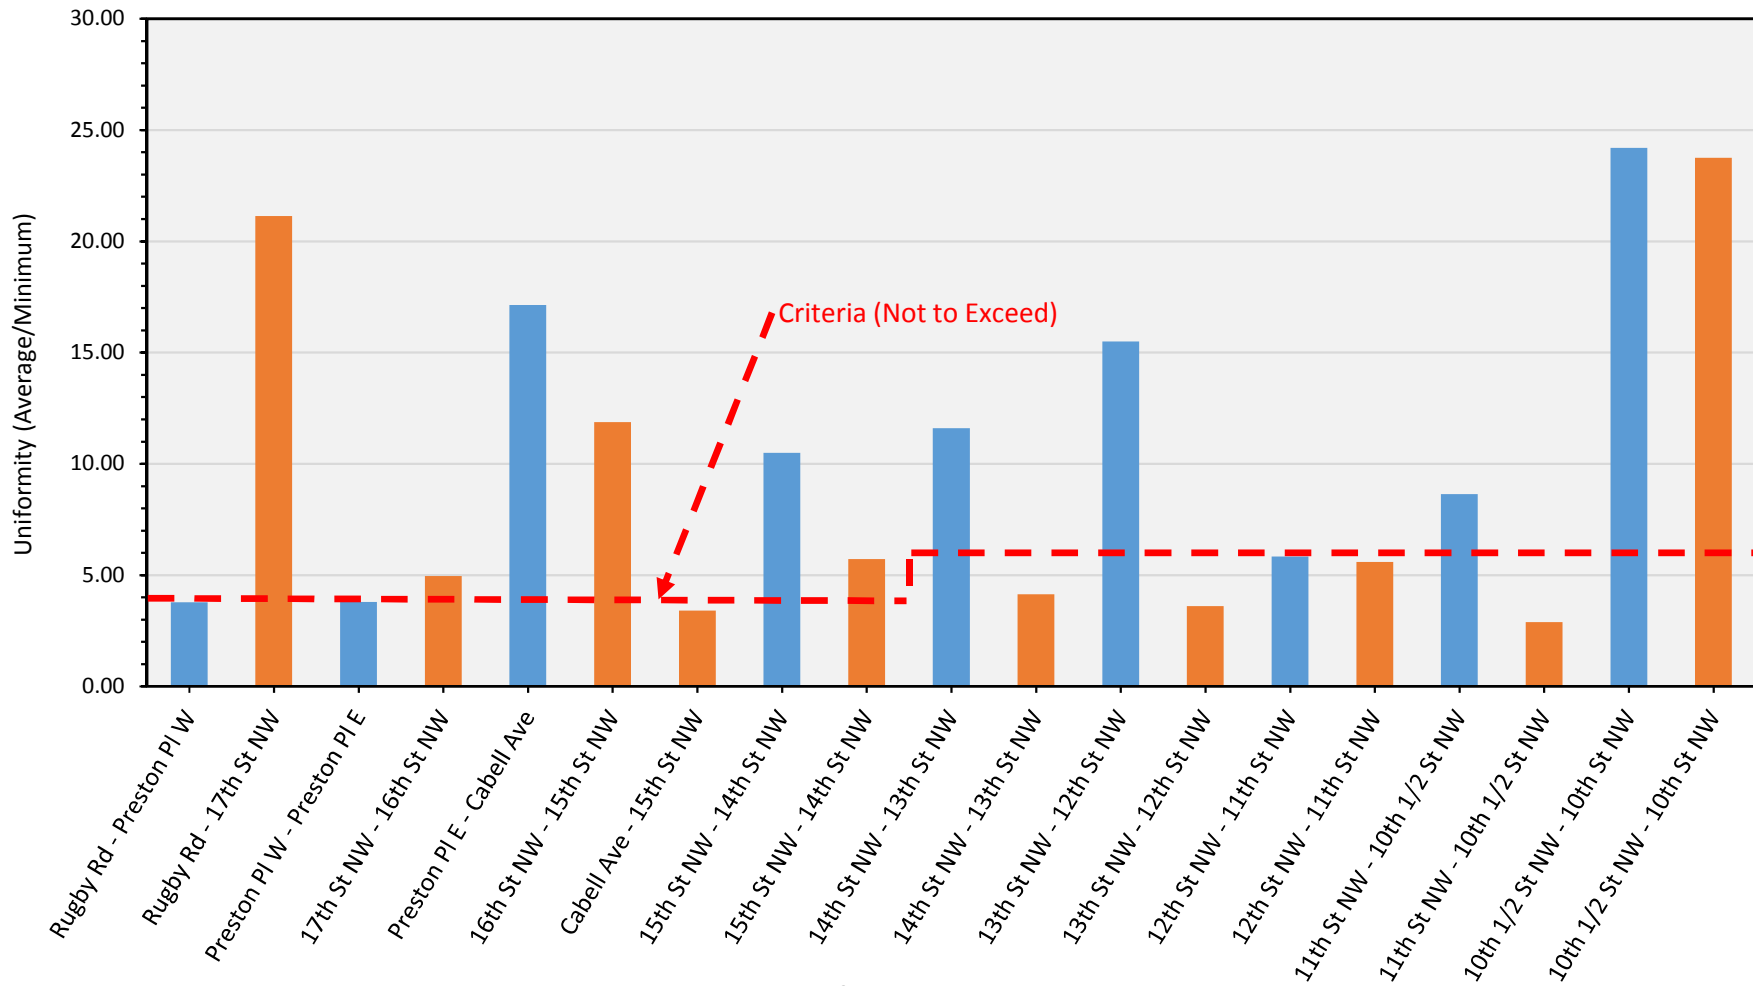
Grady Ave - Horizontal Uniformity from Existing Lighting

Grady Ave

Sidewalk Width: 5ft

Adjacent Land Use: Residential

Functional Classification: Minor Arterial

Pedestrian Activity: High, Low

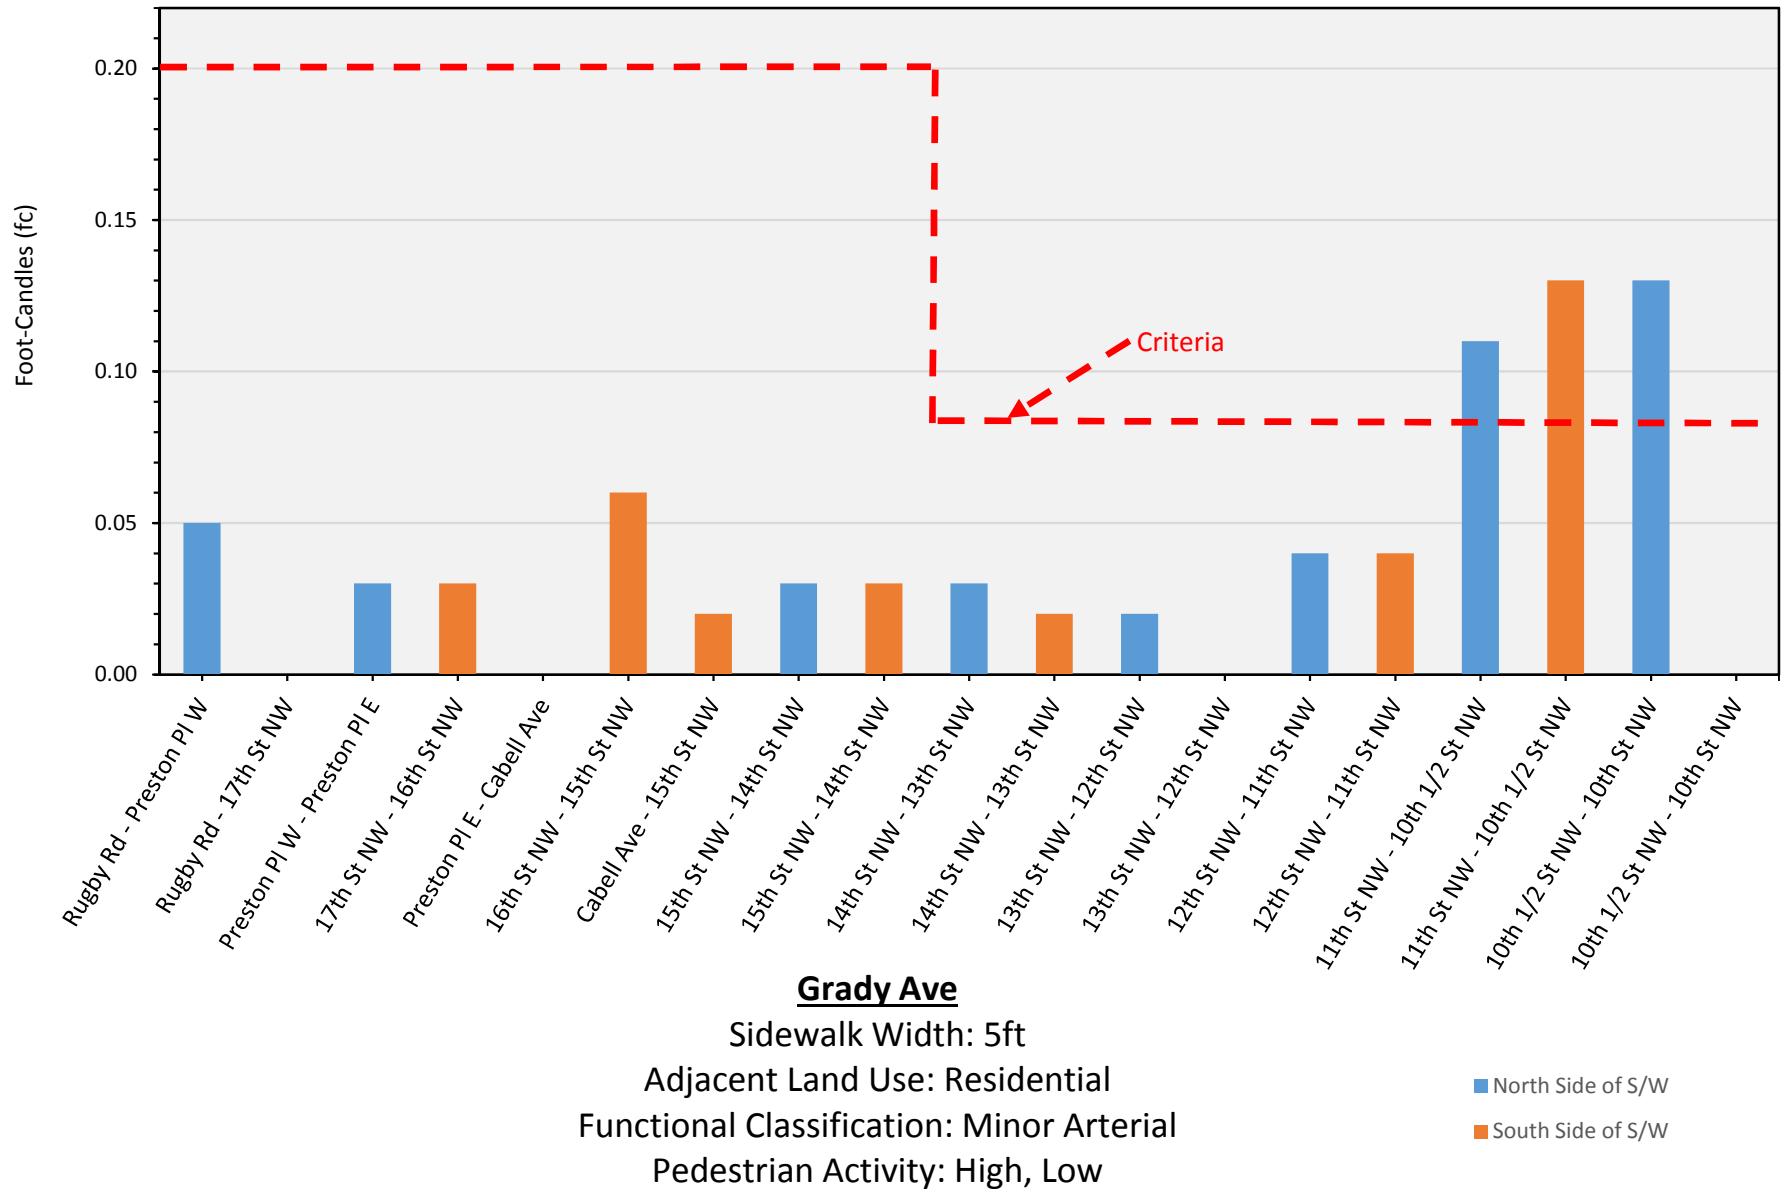
Grady Ave - Eastbound Min. Vertical Illuminance from Existing Lighting

1. Where no bar is shown, minimum Vertical value of 0.00 fc was recorded.

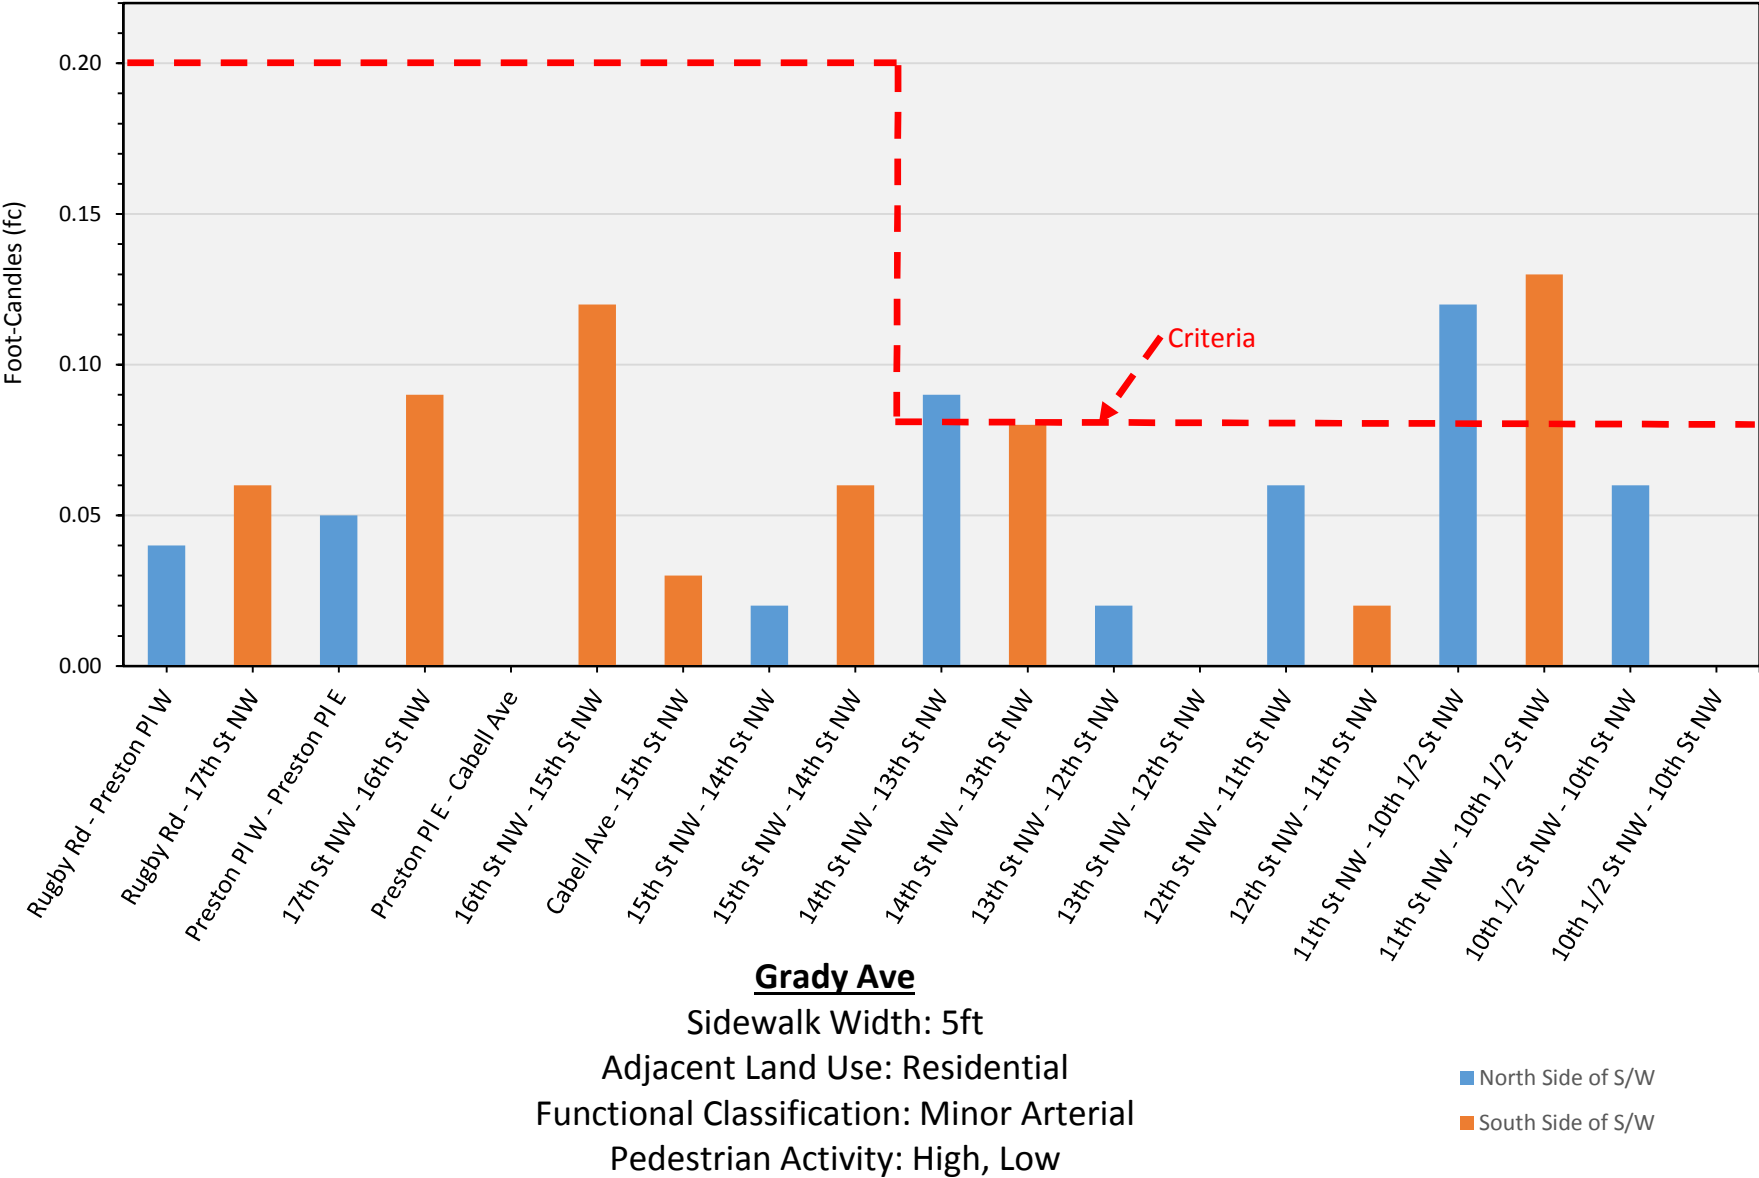
Grady Ave - Westbound Min. Vertical Illuminance from Existing Lighting

Note:
1. Where no bar is shown, minimum vertical value of 0.00 fc was recorded.

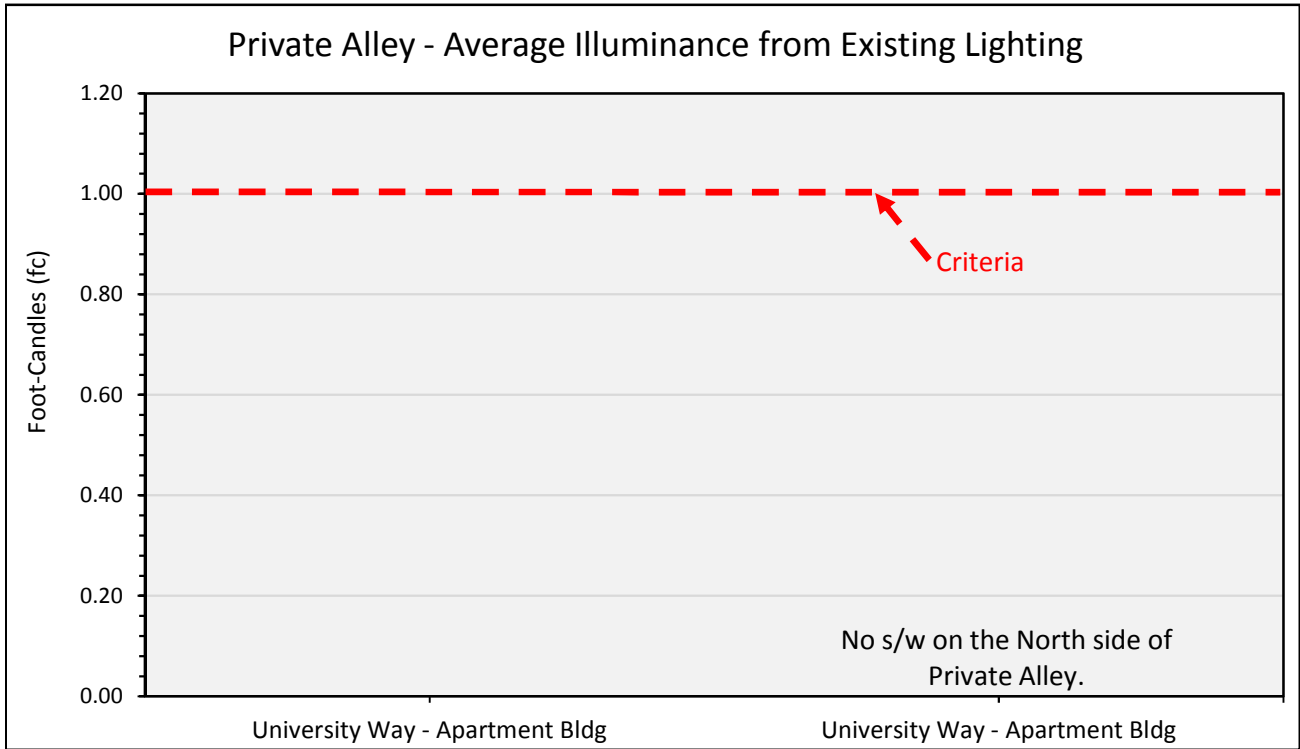
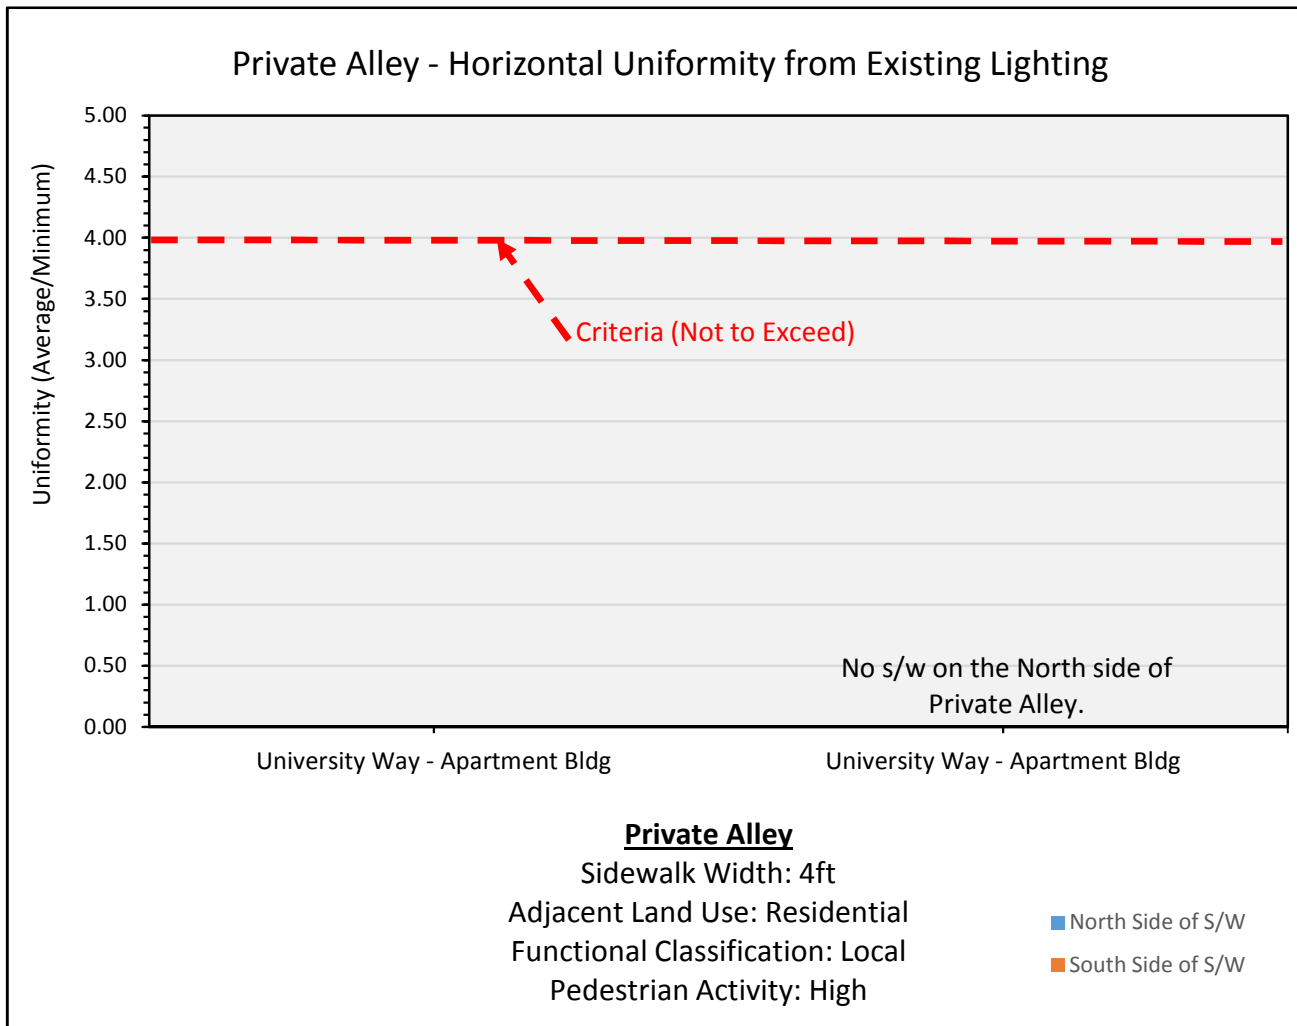
Note:

1. Where no bar is shown, average value of 0.00 fc was recorded.
2. Where no bar is shown, uniformity (average/minimum) is not within proposed criteria and cannot be calculated due to 0.00 fc minimum.

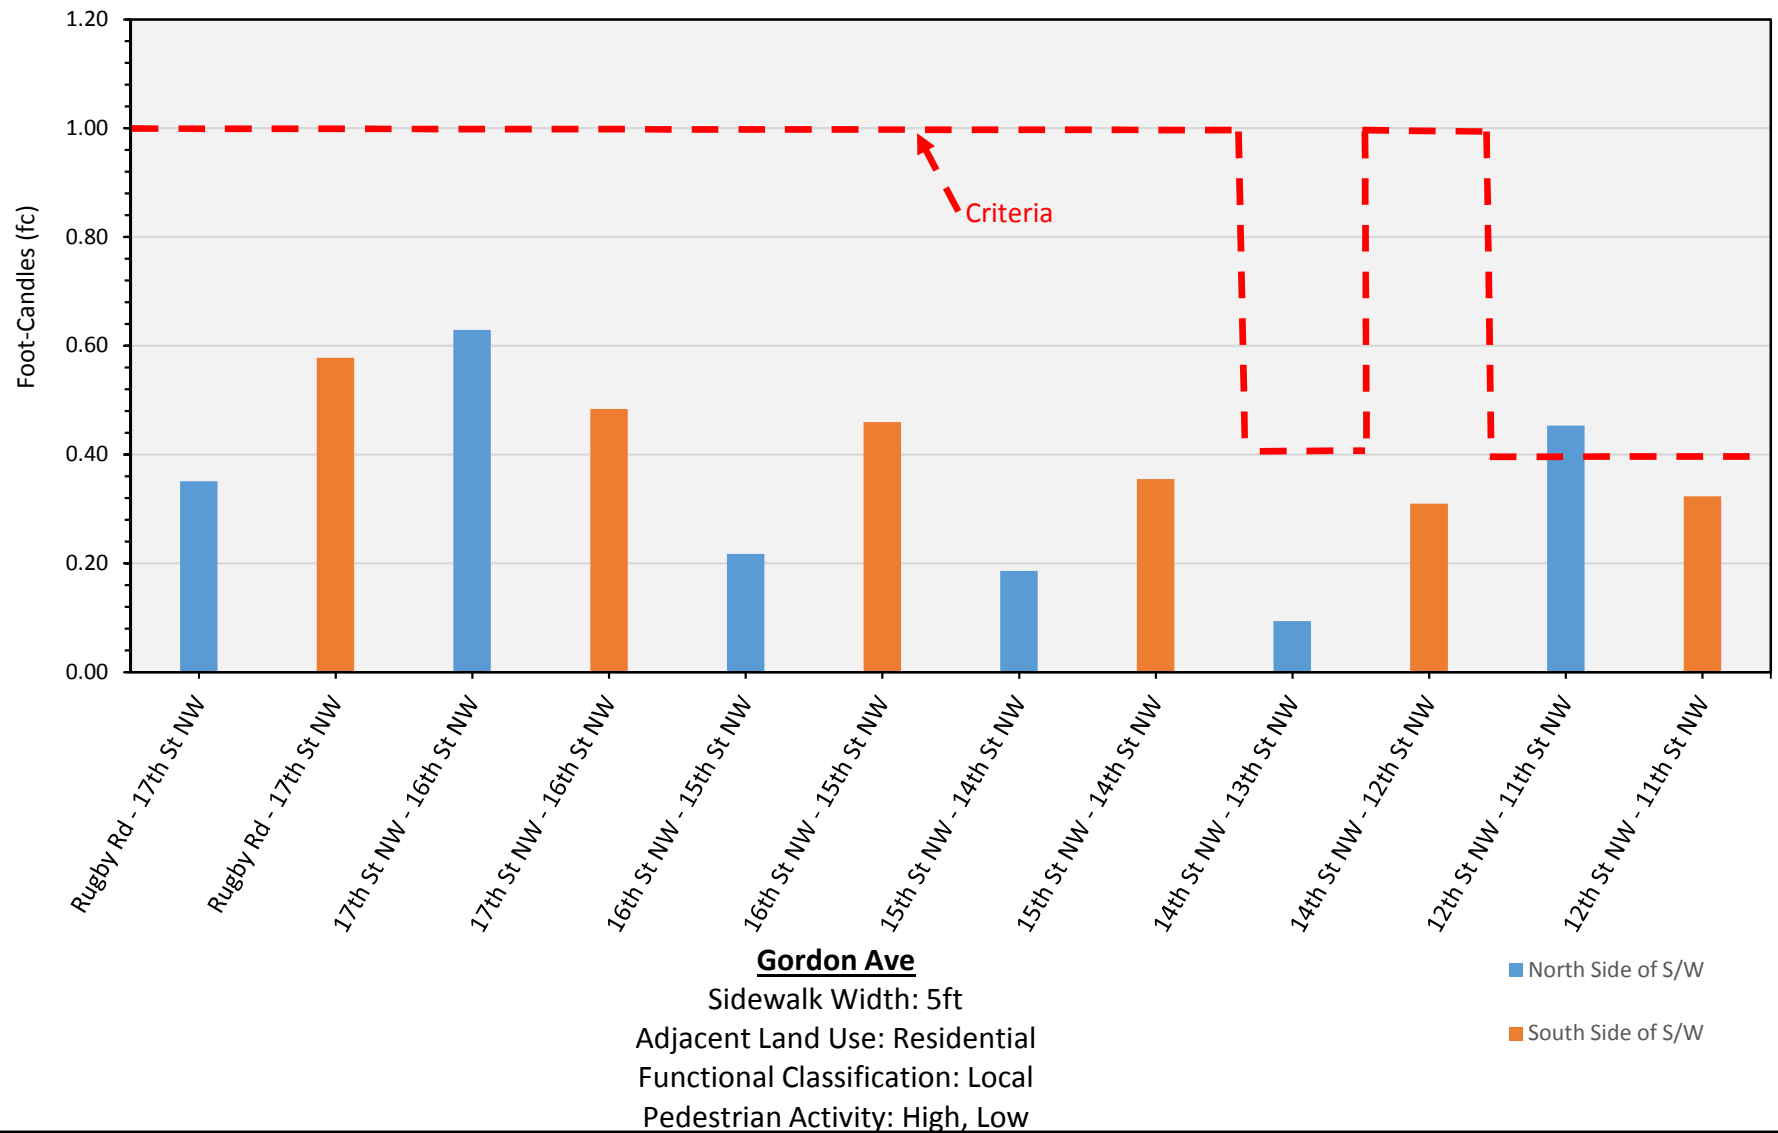
Gordon Ave - Average Illuminance from Existing Lighting

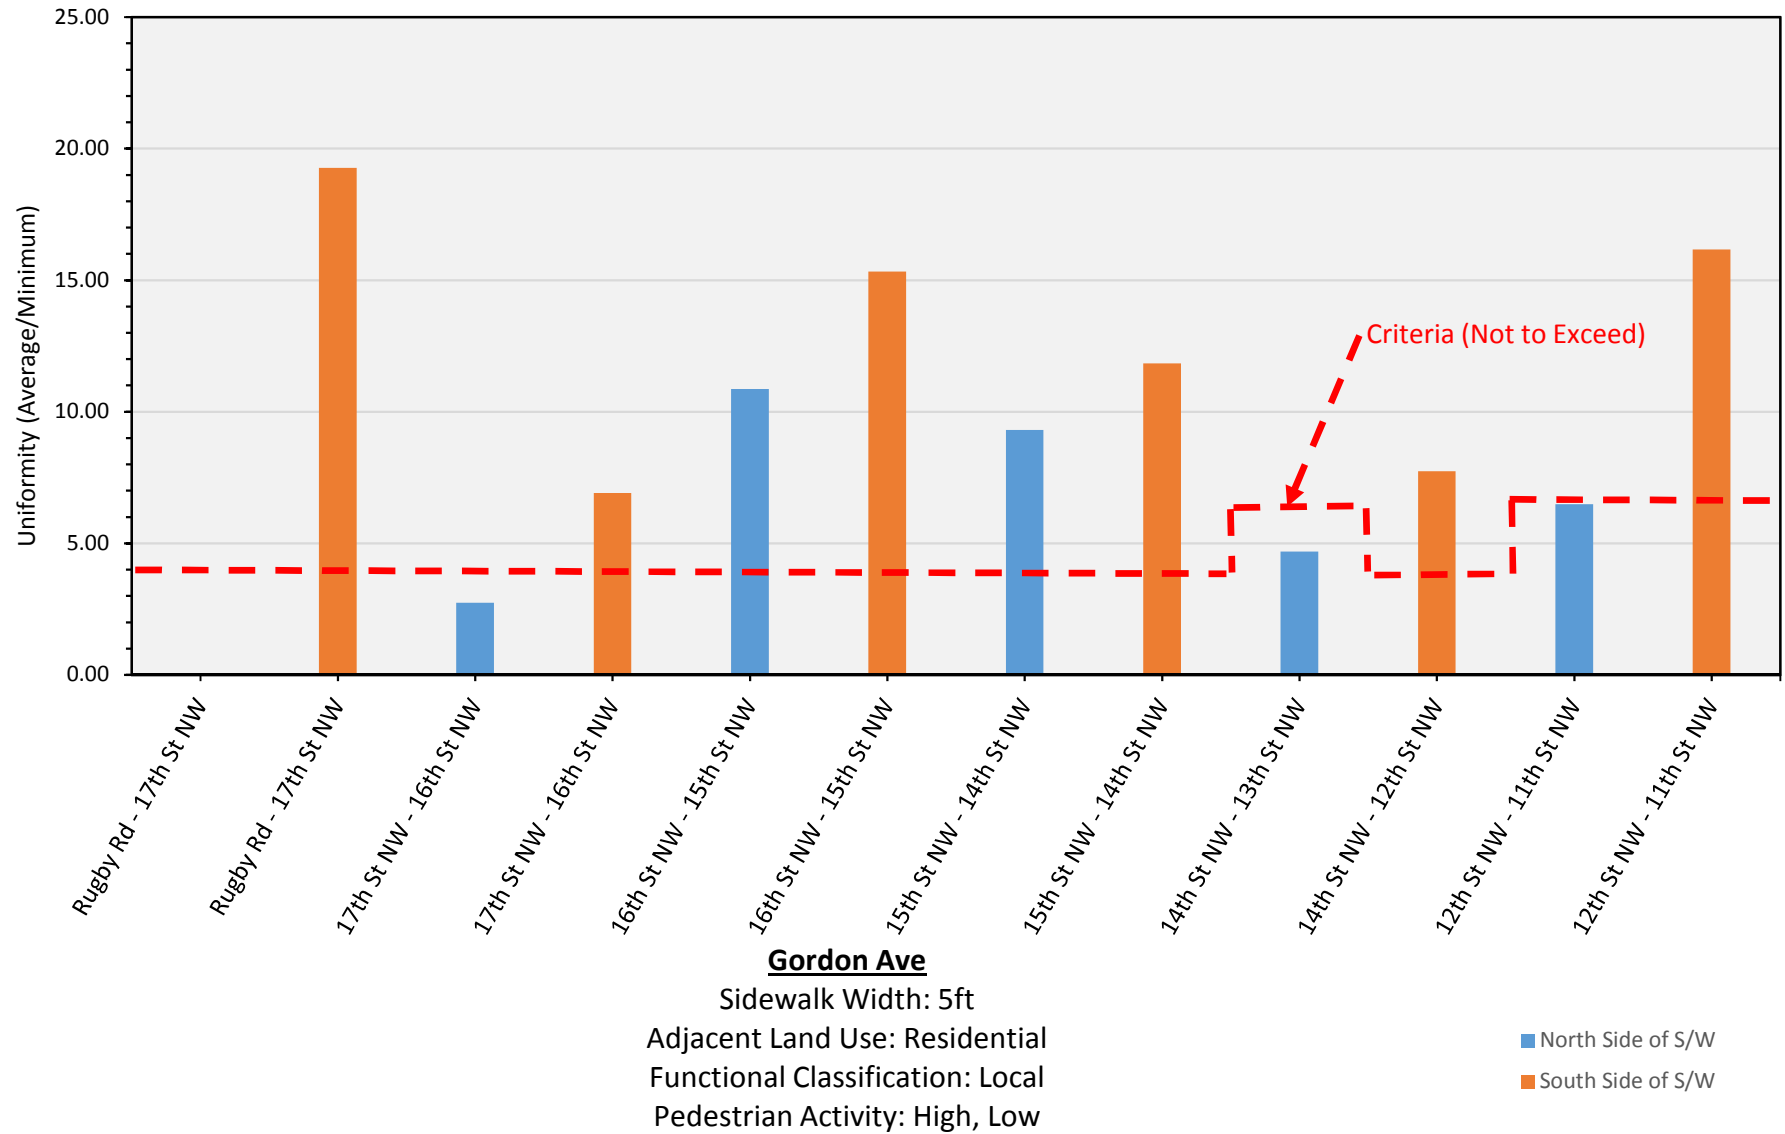
Gordon Ave - Horizontal Uniformity from Existing Lighting

1. Where no bar is shown, uniformity (average/minimum) is not within proposed criteria and cannot be calculated due to 0.00 fc minimum.

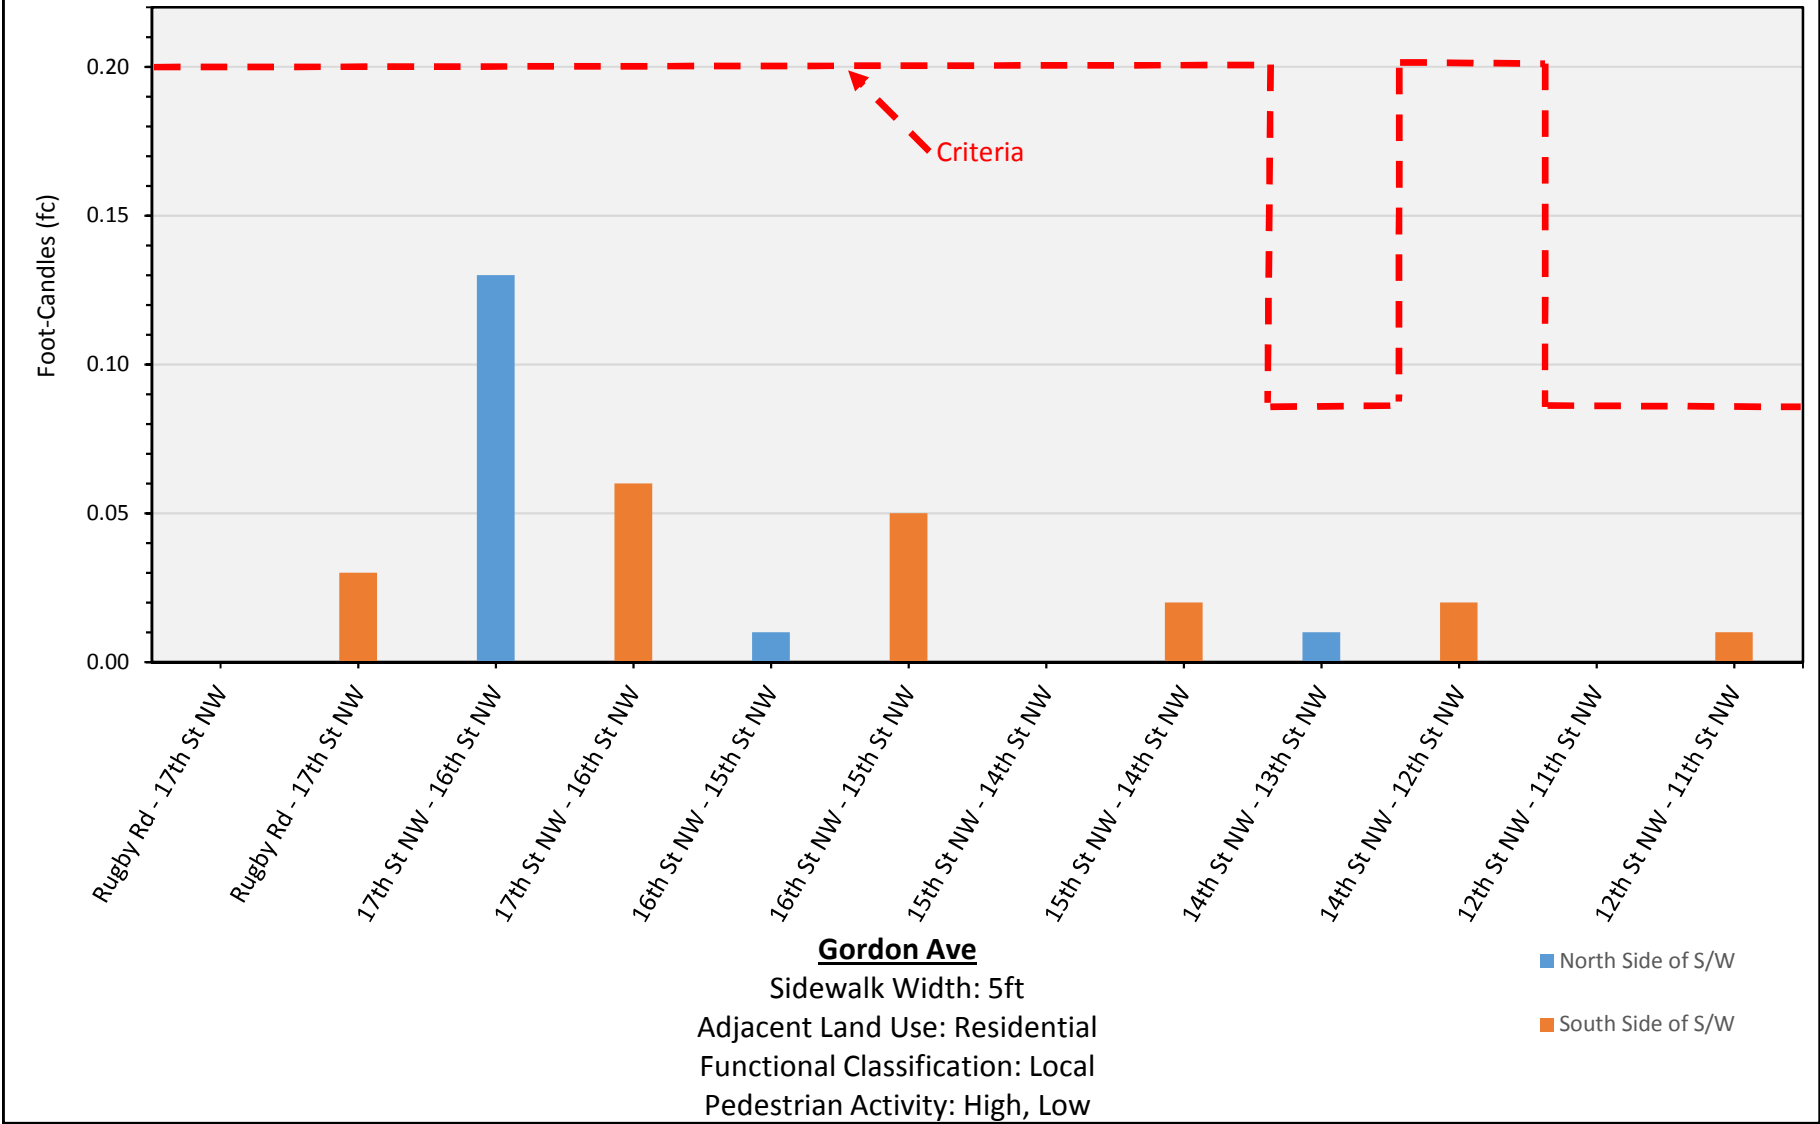
Gordon Ave - Eastbound Min. Vertical Illuminance from Existing Lighting

Note:
1. Where no bar is shown, minimum vertical value of 0.00 fc was recorded.

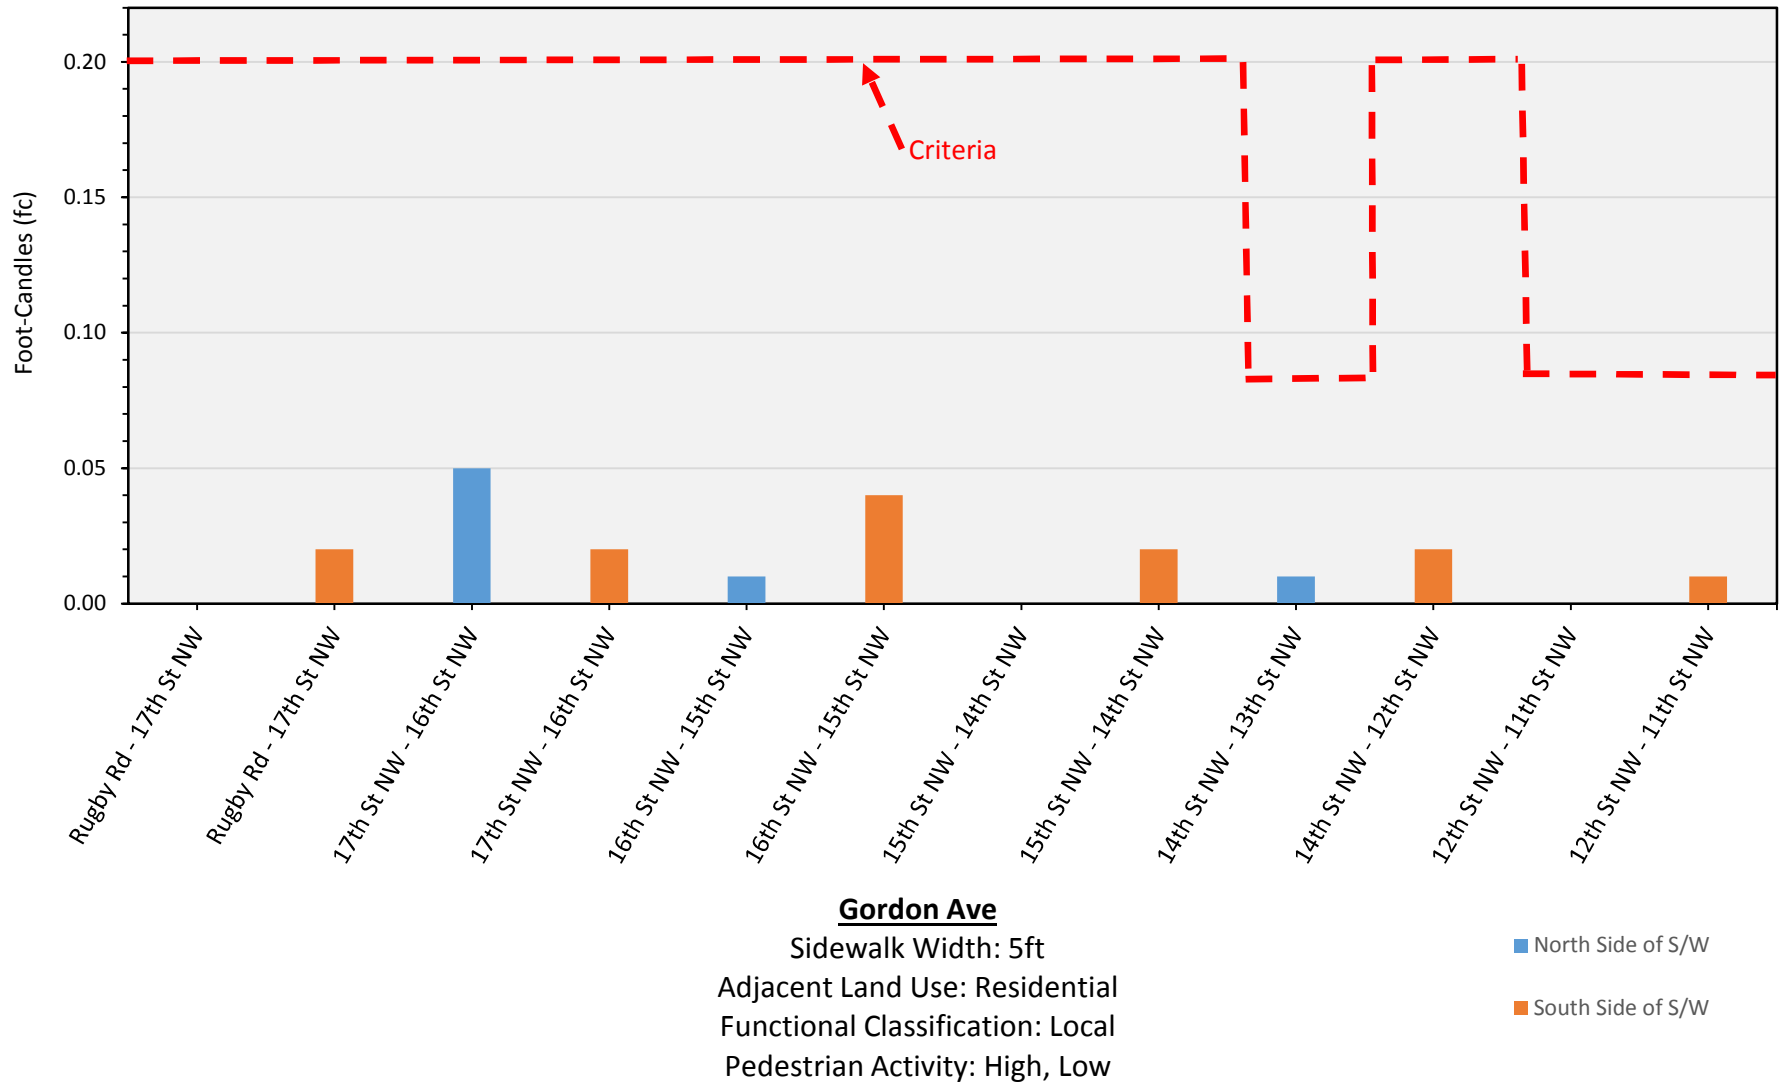
Gordon Ave - Westbound Min. Vertical Illuminance from Existing Lighting

1. Where no bar is shown, minimum vertical value of 0.00 fc was recorded.

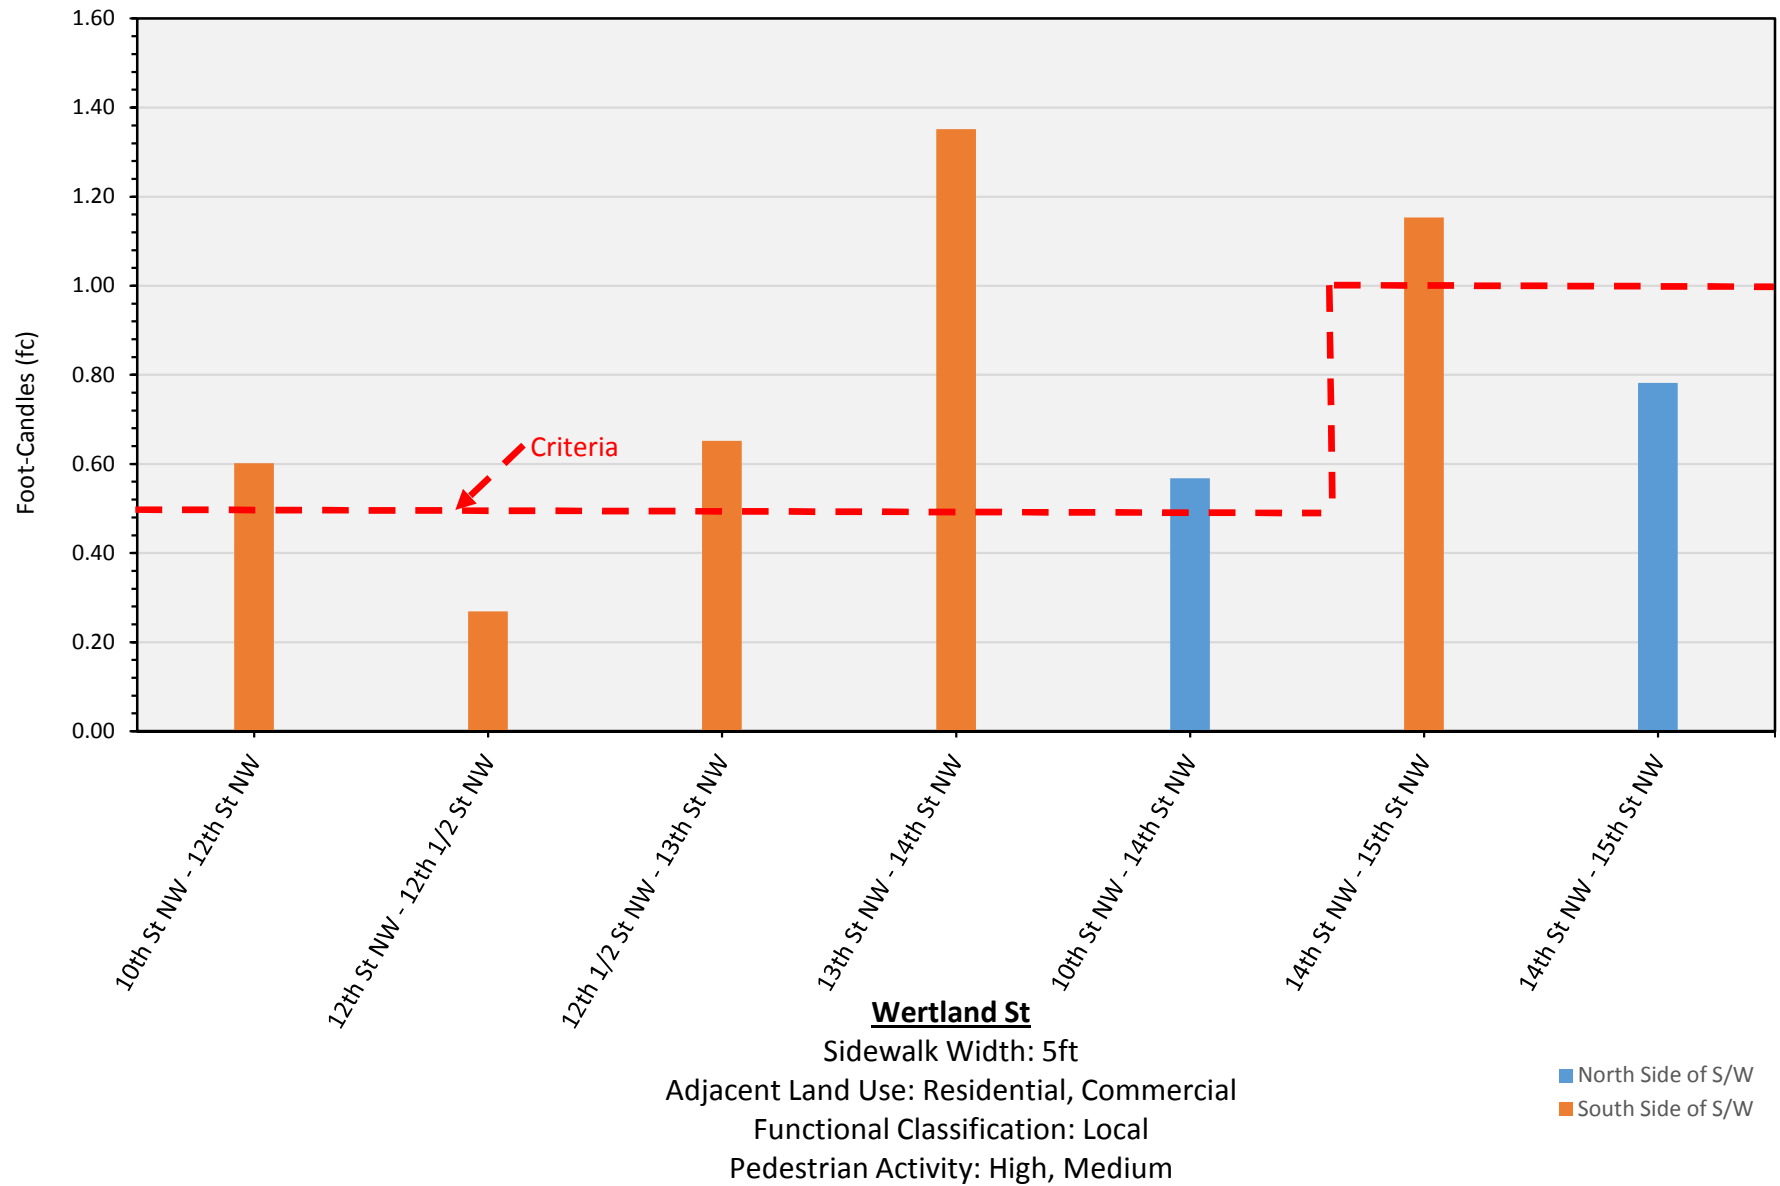
Wertland St - Average Illuminance from Existing Lighting

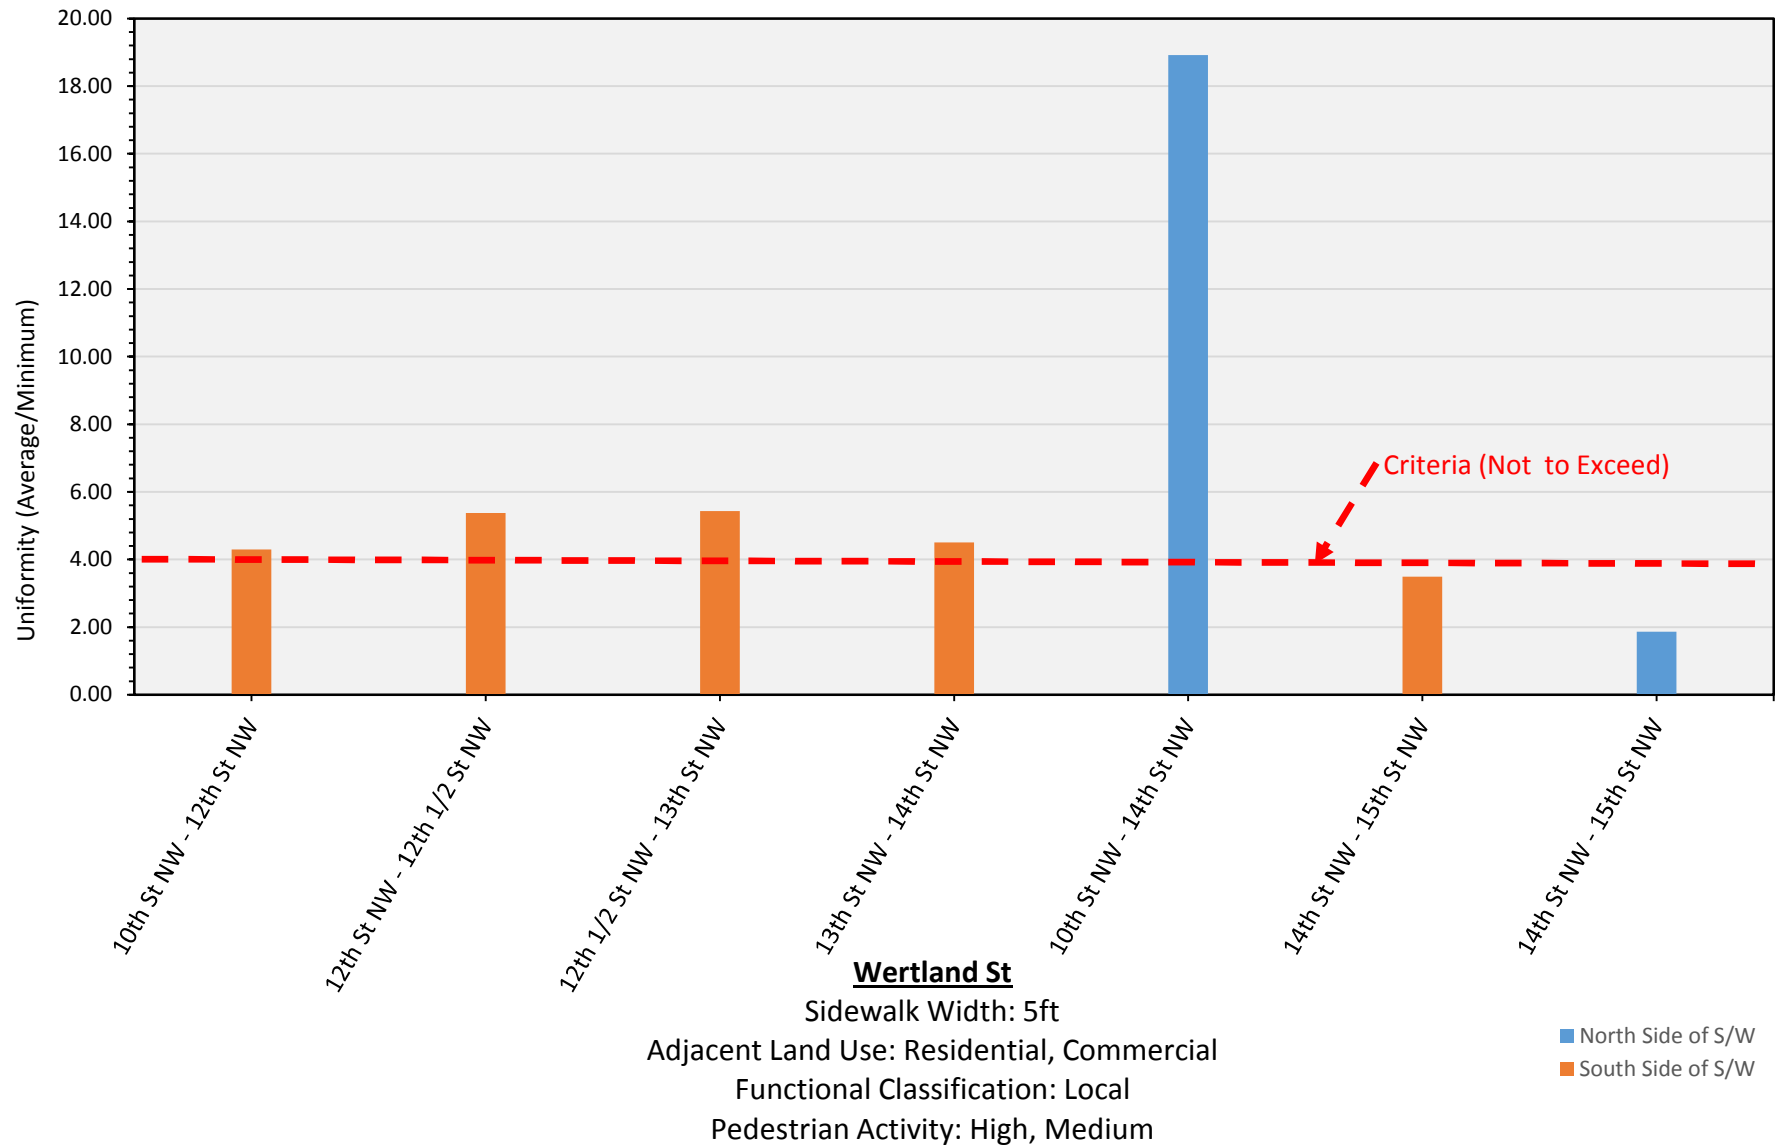
Wertland St - Horizontal Uniformity from Existing Lighting
